CITY OF BALTIMORE WET WEATHER CONSENT DECREE SMOKE AND DYED WATER TESTING FORM		Page 1 of 4
Sewershed: Low Level Subsewershed: 41	Company: REI/DRAYCO	Date: 08/05/2008
Test Type: Smoke	Ground Condition: Dry: X Damp: _ Wet: _	Supervisor: E.R. Crew: 04
Manhole ID: S21K1_022MH	Test ID: 1029-518	Notifications Made: __X__ Residents, Fire, 311
Field Sketch: (Show all manholes with numbers, blower placement location, sandbag or isolation locations, street names, building addresses and locations, defect locations and photograph numbers)

CITY OF BALTIMORE
SMOKE TESTING OBSERVATION SUMMARY
LOW LEVEL SEWERSHED
BALTIMORE CITY PROJECT 1029
REI/DRAYCO

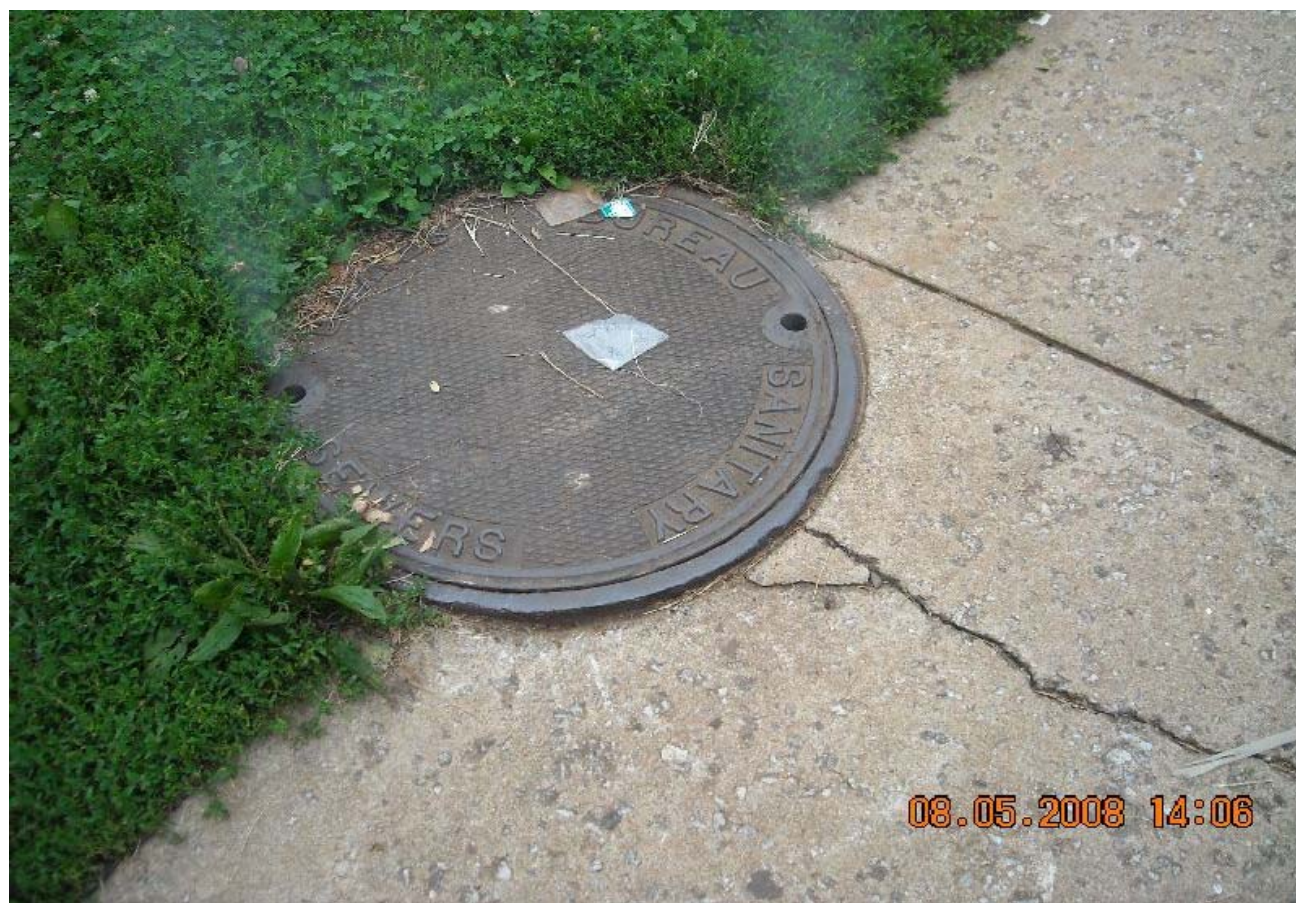
Photograph No: OB01-01
Filename: 1029-518_OB01-01.jpg

Unique Test ID: 518	Date: 08/05/2008	Basin: LL - 41	Manhole ID: S21K1_022MH
Defect No: OB01	Supervisor: E.R.	Crew: 04	Dye Test Recommended: N
Location: S21K1_005MH			
Source Type: 10 MH Frame		Location: 05 Sidewalk	
Sector: 01 Public		Severity: 03 Moderate	Drainage Area: 6
Comments: SMOKE COMING FROM AROUND RIM OF S21K_005MH.

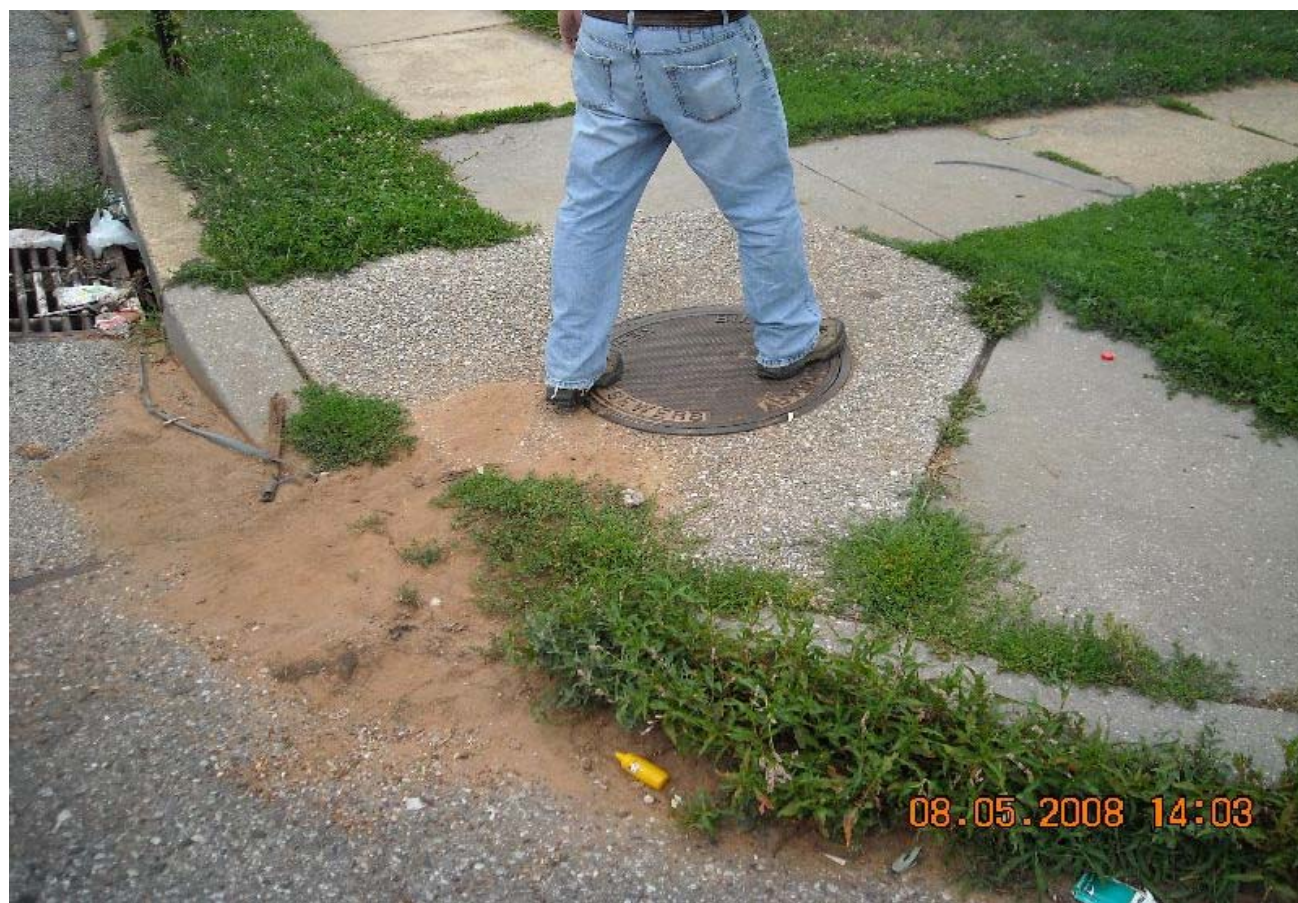
Photograph No: OB02-01
Filename: 1029-518_OB02-01.jpg

Unique Test ID: 518	Date: 08/05/2008	Basin: LL - 41	Manhole ID: S21K1_022MH
Defect No: OB02	Supervisor: E.R.	Crew: 04	Dye Test Recommended: N
Location: S21K1_026MH			
Source Type: 10 MH Frame		Location: 05 Sidewalk	
Sector: 01 Public		Severity: 03 Moderate	Drainage Area: 6
Comments: SMOKE COMING FROM AROUND RIM OF S21K_026MH.
